CONDITION SURVEYS OF PAVEMENTS SUB-
JECTED TO CHANNELIZED TRAFFIC, REPORT 2,
MARCH AIR FORCE BASE, RIVERSIDE,
CALIFORNIA

CONDITION SURVEYS OF PAVEMENTS
SUBJECTED TO CHANNELIZED TRAFFIC
MARCH AIR FORCE BASE
RIVERSIDE, CALIFORNIA

MISCELLANEOUS PAPER NO. 4-213

Report 2

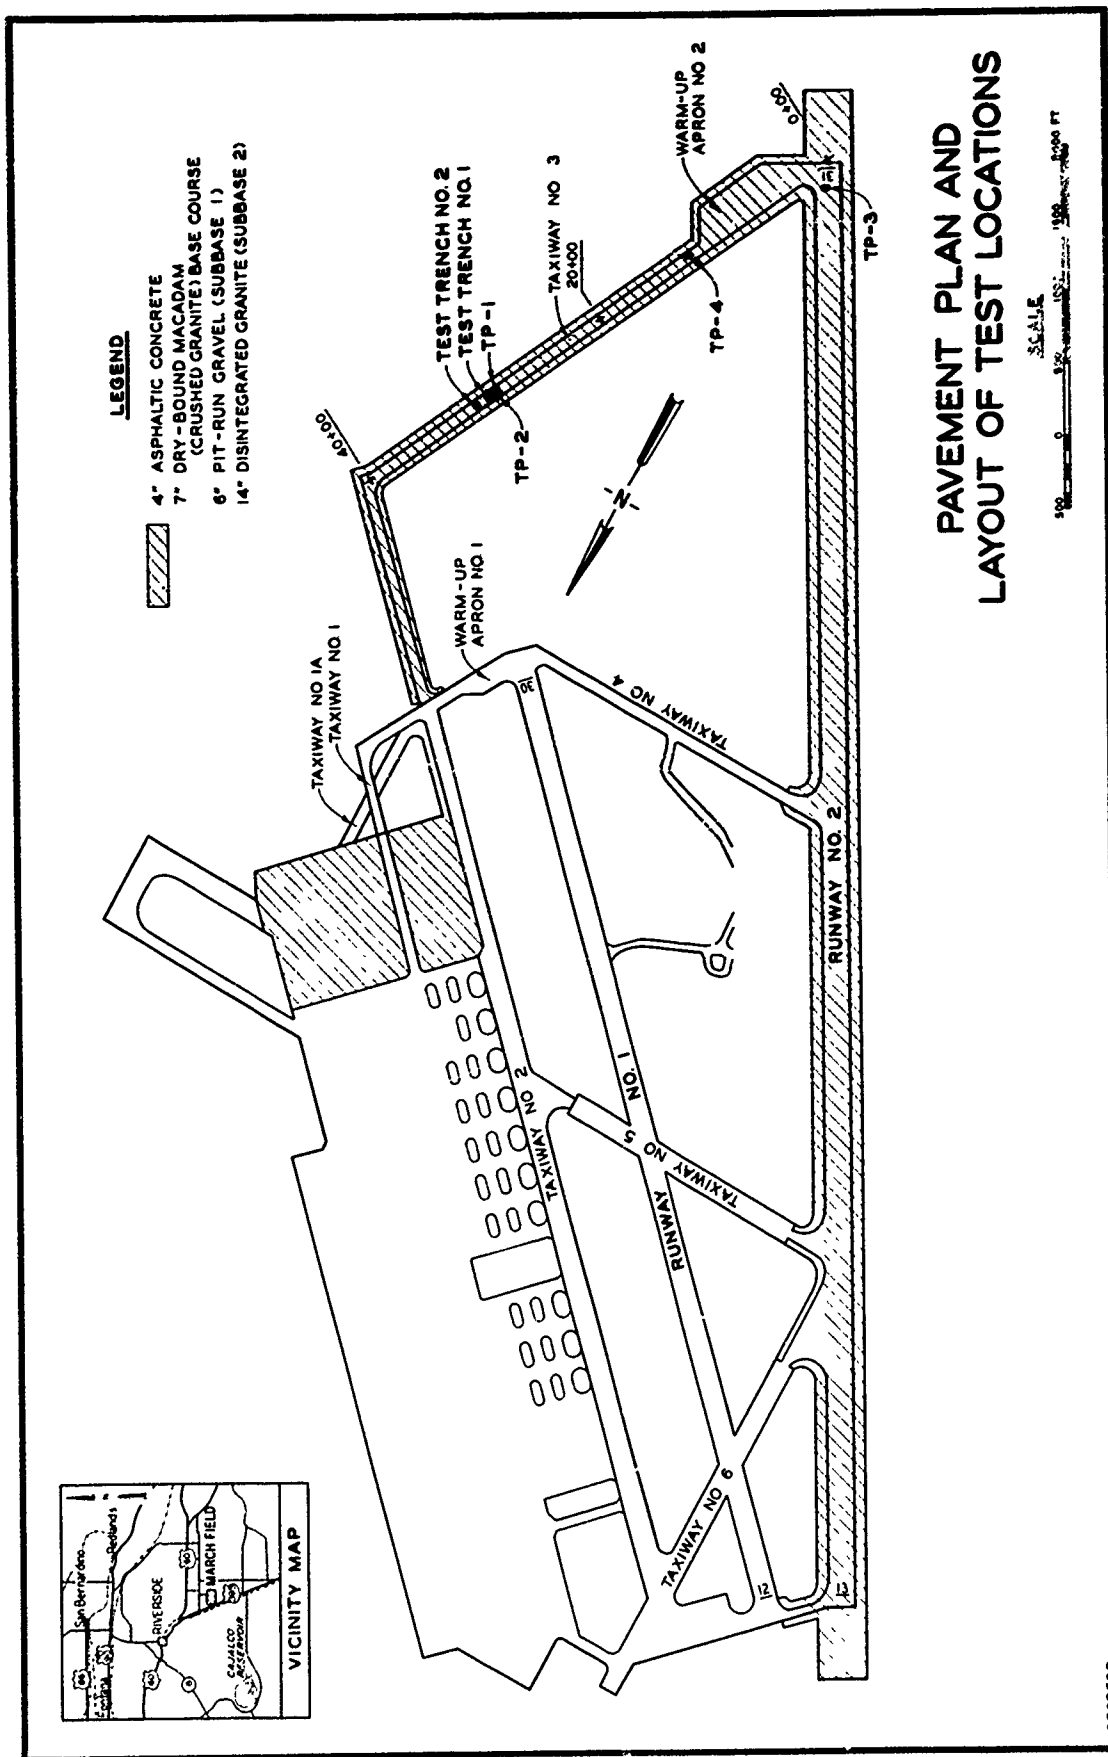
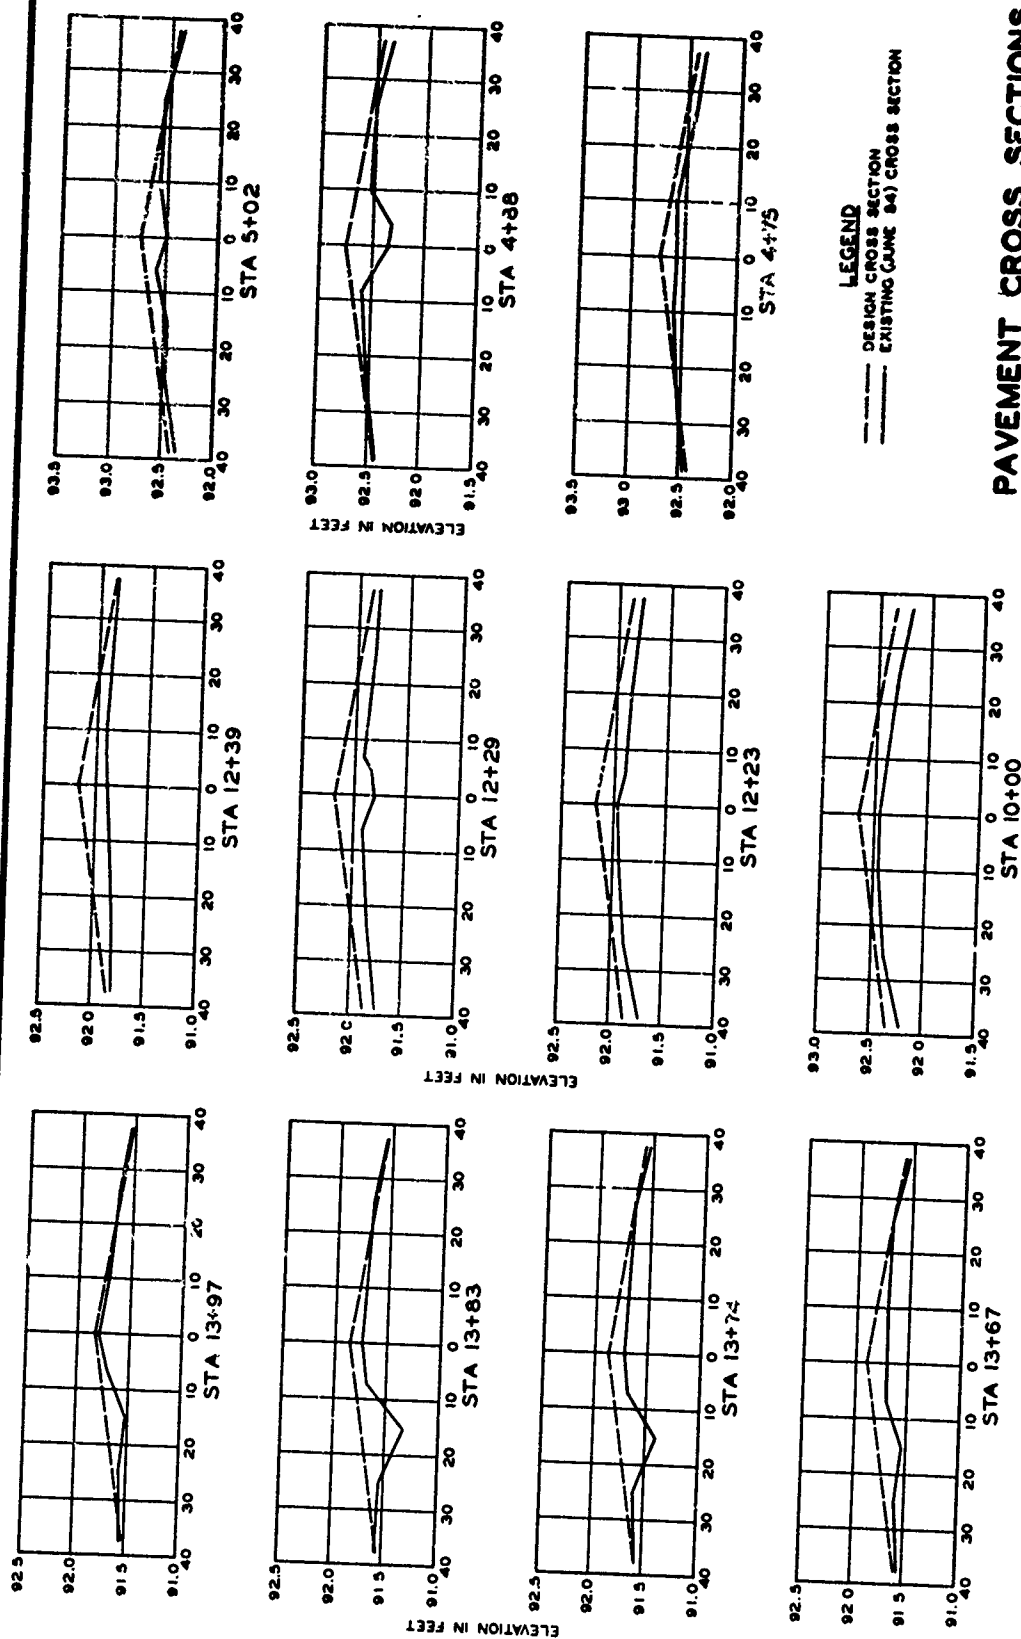
PAVEMENT CROSS SECTIONS
TAXIWAY 3
STA 4+75 TO STA 13+97

As indicated in the above table, testing was performed in areas where channelized traffic occurred and outside the areas of channelized traffic so that pavement behavior under different traffic conditions could be studied. The LAD tests were performed on the original taxiway pavement which consisted of about 4 in. of asphaltic concrete. WES test pits 1 and 4 were in areas where a leveling course had been placed prior to the overlay, while test pits 2 and 3 were in areas that had not required a leveling course but had been overlaid with only about 2 in. of asphaltic concrete. WES testing extended into the subsoil layer to a somewhat greater depth than the LAD test trenches. Data from test pit 3 were not intended for comparison of test results but were an attempt to determine the cause of the pavement depression that had occurred in the southeastern portion of runway 2. The deformation that had occurred on the taxiway is indicated on the pavement cross sections, plates 2 and 3.
